# Situation of wastewater management under disasters

Kikuya Shibata

Secretary General of Miyagi Prefectural Authority for Living Environment

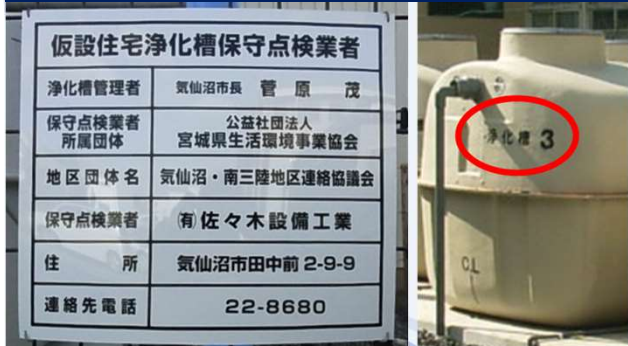
improvement approach for maintenance (sign boards and numbering)

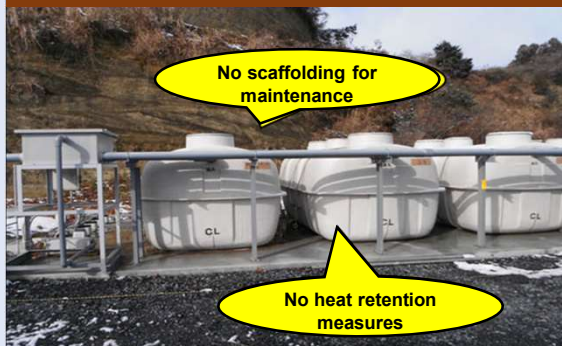
No scaffolding for maintenance  
No heat retention measures

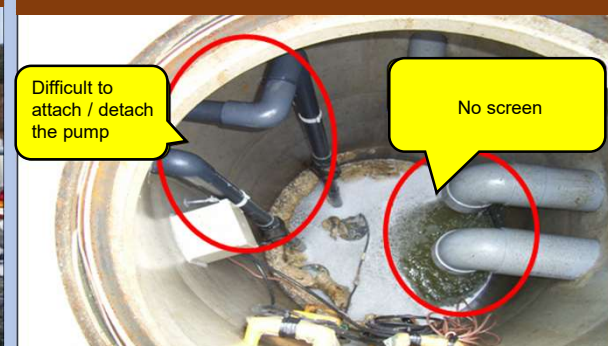
Inadequate screen equipment

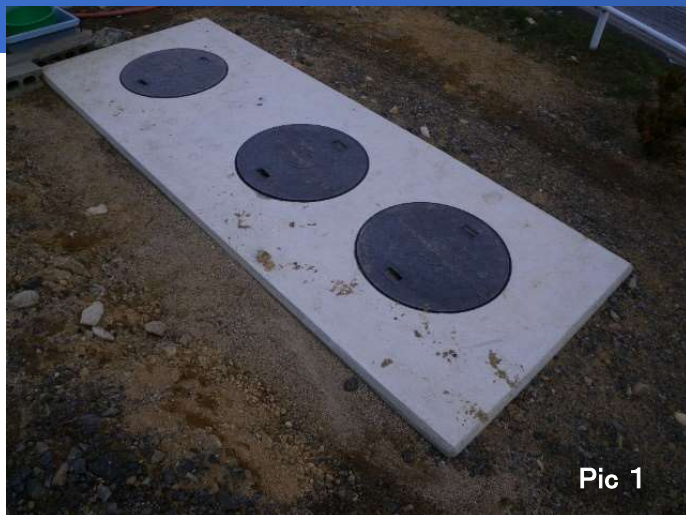
Pic 1

Iwate Prefecture  
(underground : 35 PE)

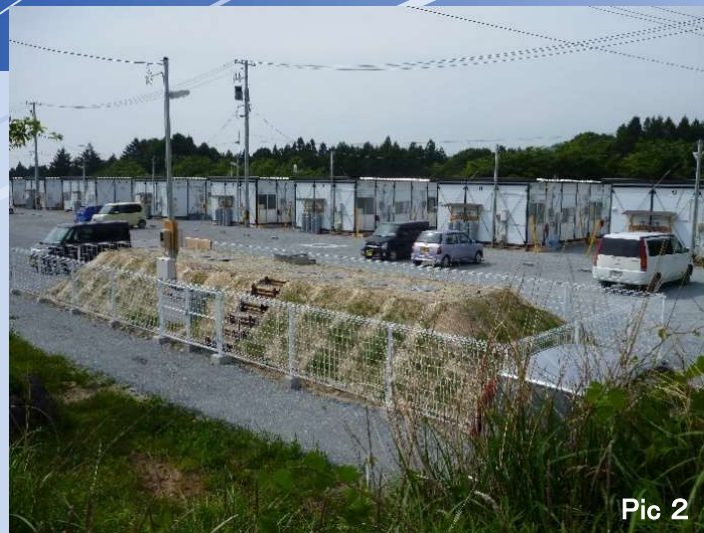
Pic 2

Fukushima Prefecture  
(Semi-underground installation + embankment:  
45 EP × 2 units)

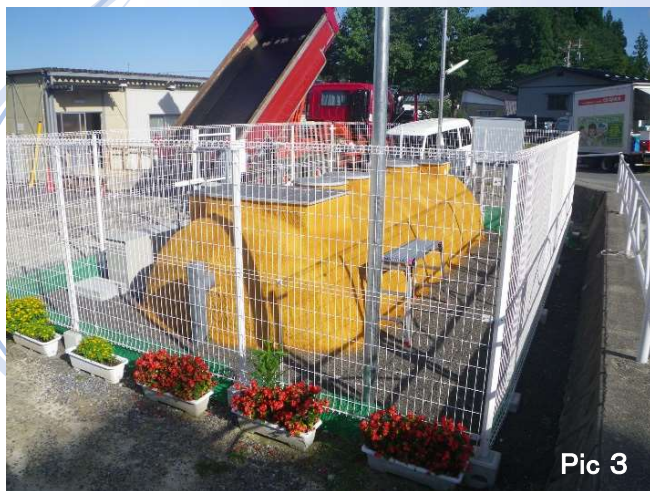
Pic 3

Iwate Prefecture  
(Semi-underground installation,  
heat retention measures : 42 PE)

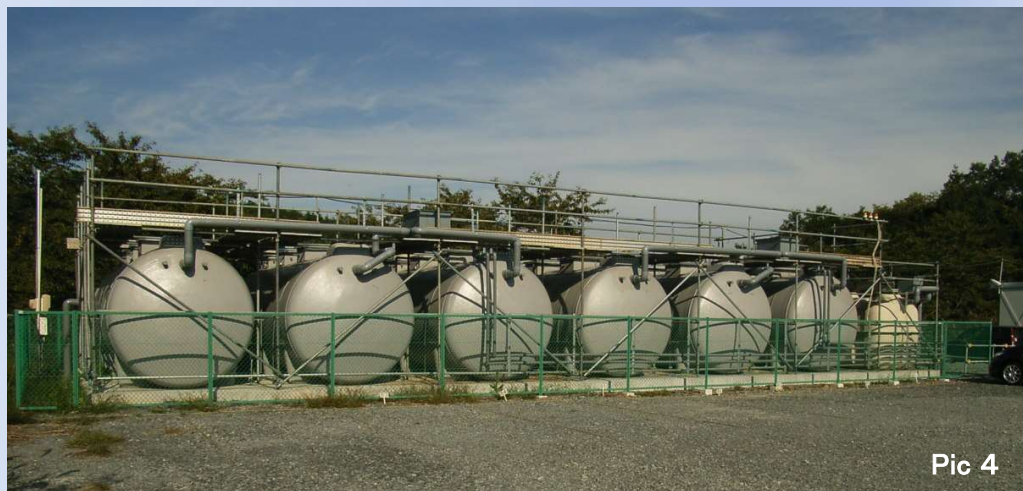
Pic 4

Iwate Prefecture  
(Ground installation, No heat retention measures:  
90 PE × 6 units + 30 PE)
