Earth Creative

2. Wastewater treatment System in Indonesia

2. Wastewater treatment system in Indonesia

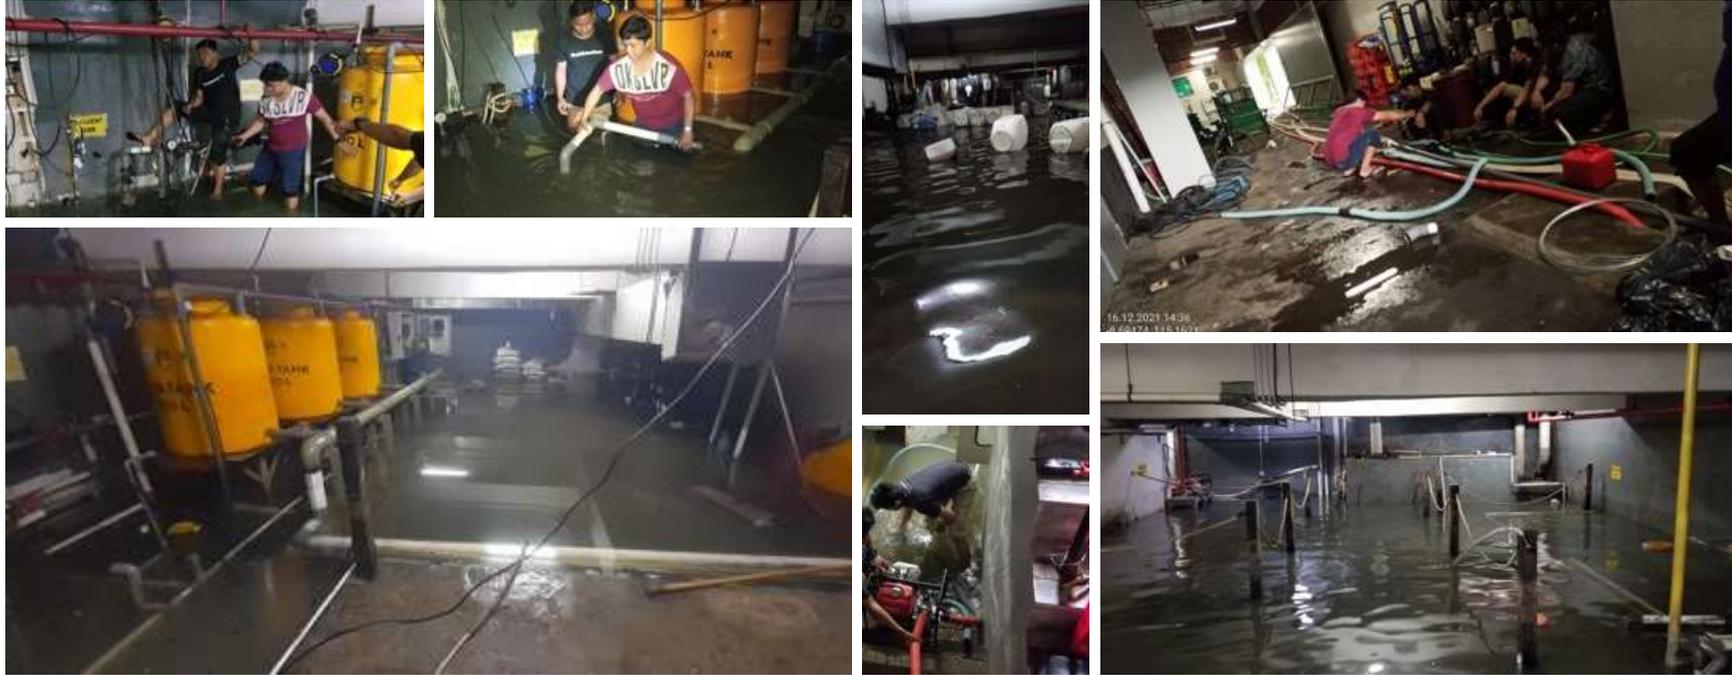
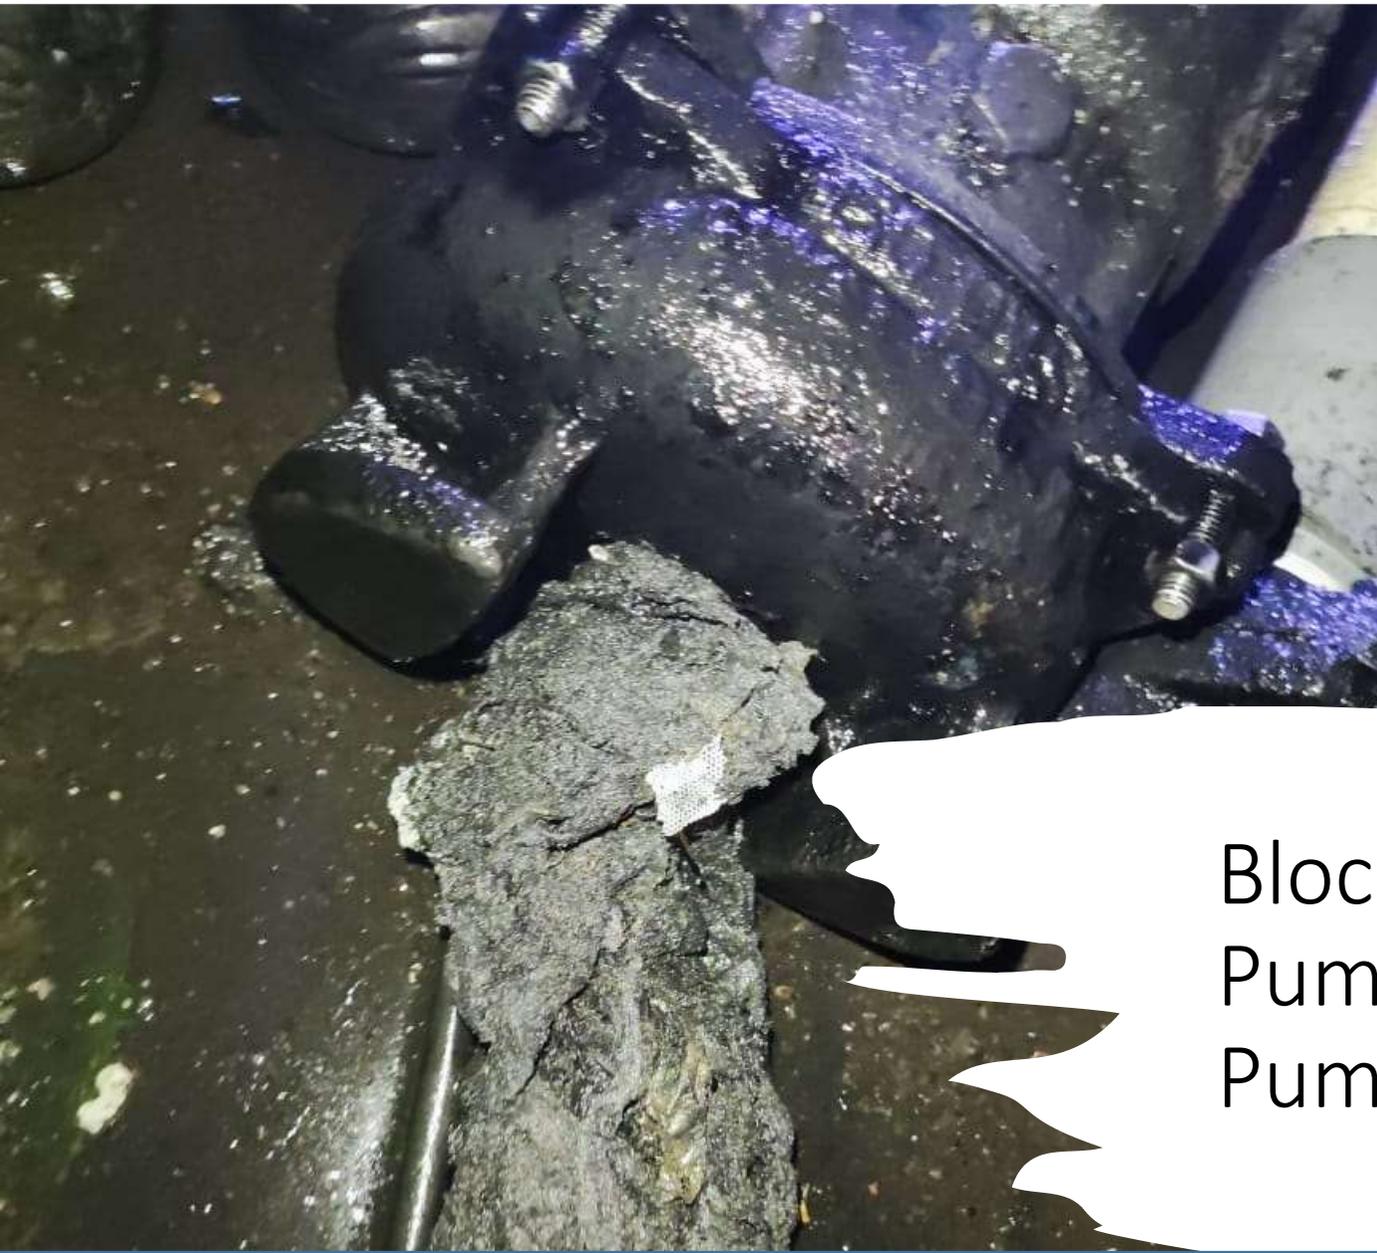
Flooded Wastewater treatment Plant

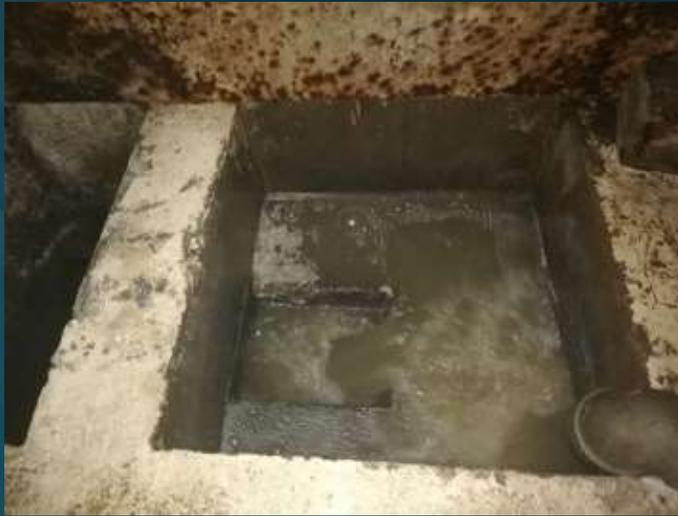
After Adjustment

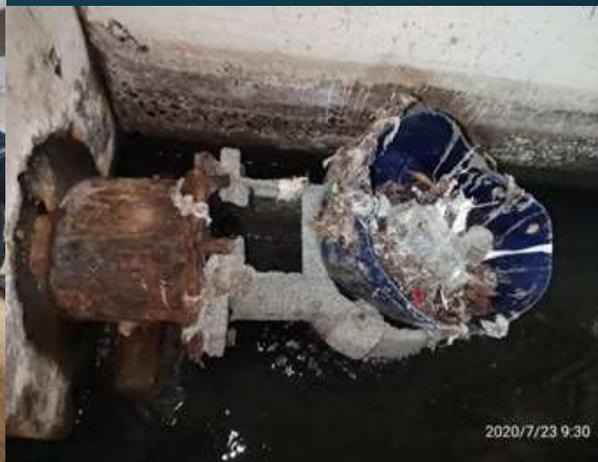
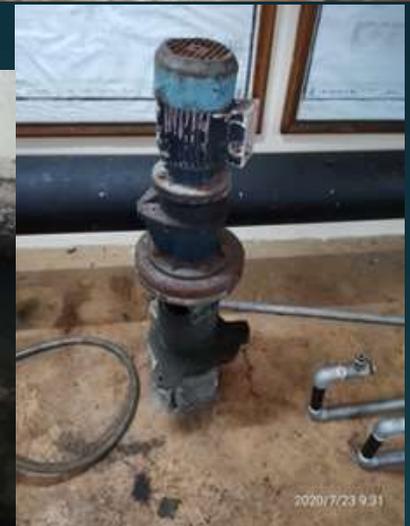
Water quality, equipment maintenance
