Treatment of Wastewater including human waste in disasters

~ Heavy rain disaster and countermeasure ~

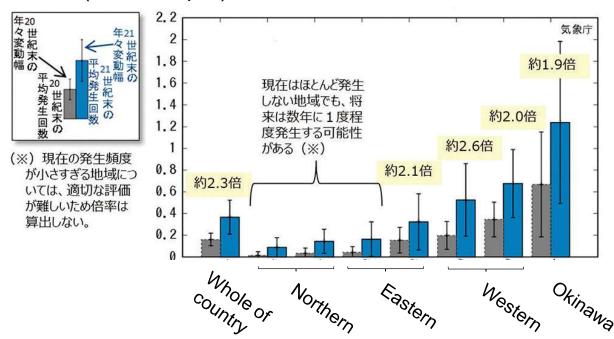
Changes in number of annual occurrences of heavy rain in Japan (more than 200mm of daily precipitation)

Gray bar: average number of occurrences at the end of the 20th century

Blue bar: assumed number of occurrences under high level discharge of CO₂

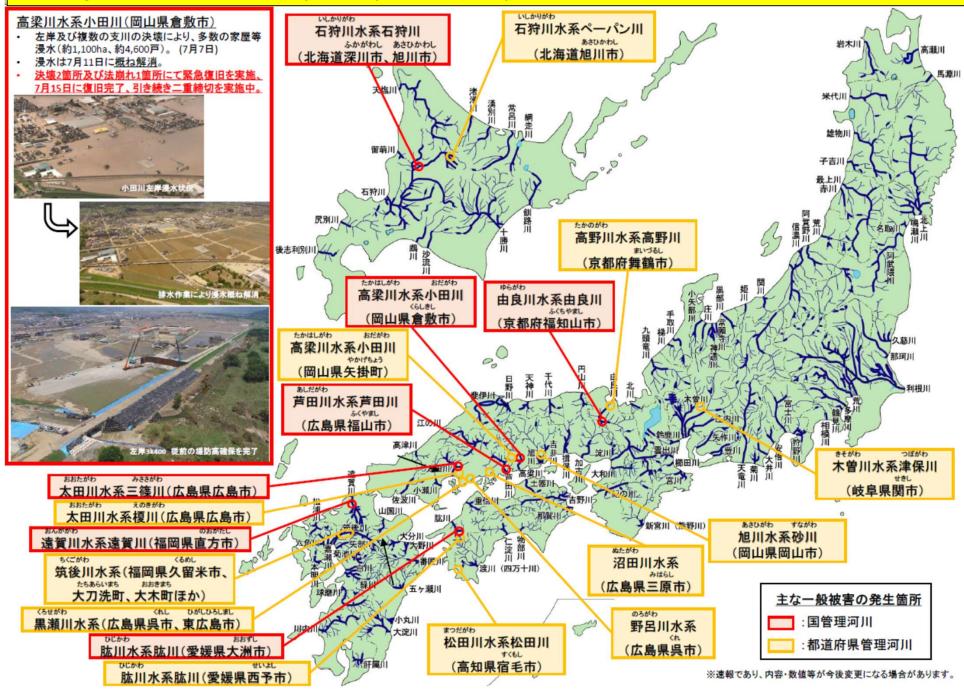
Damage to rivers caused by heavy rain on July 2018

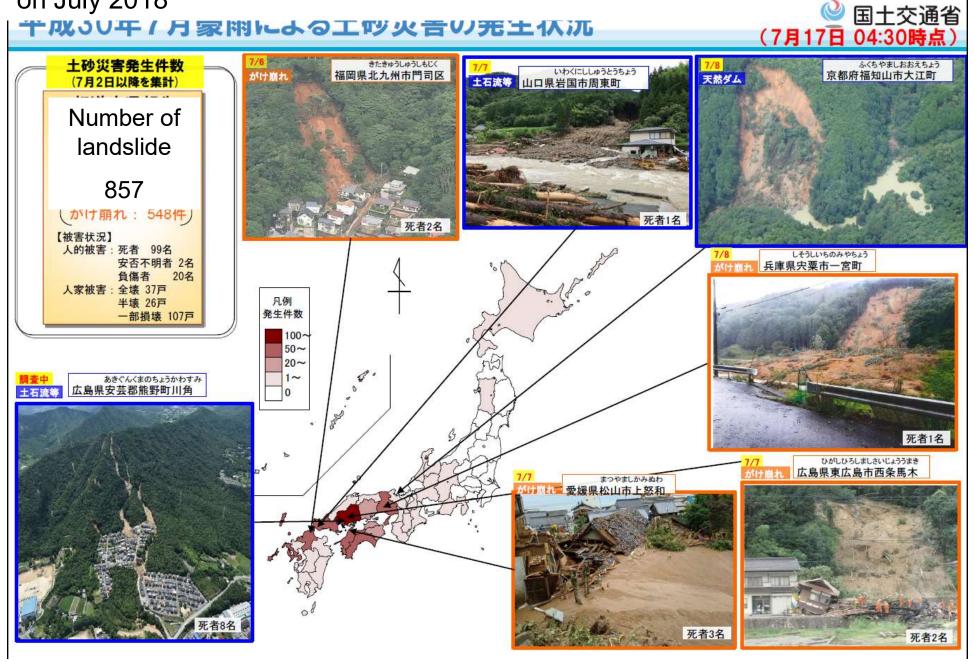
Situation of landslide disaster caused by heavy rain on July 2018

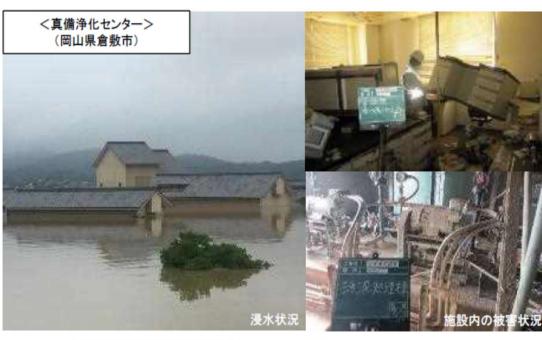
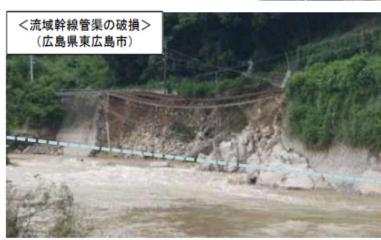
Damage to sewage treatment system caused by heavy rain on July 2018

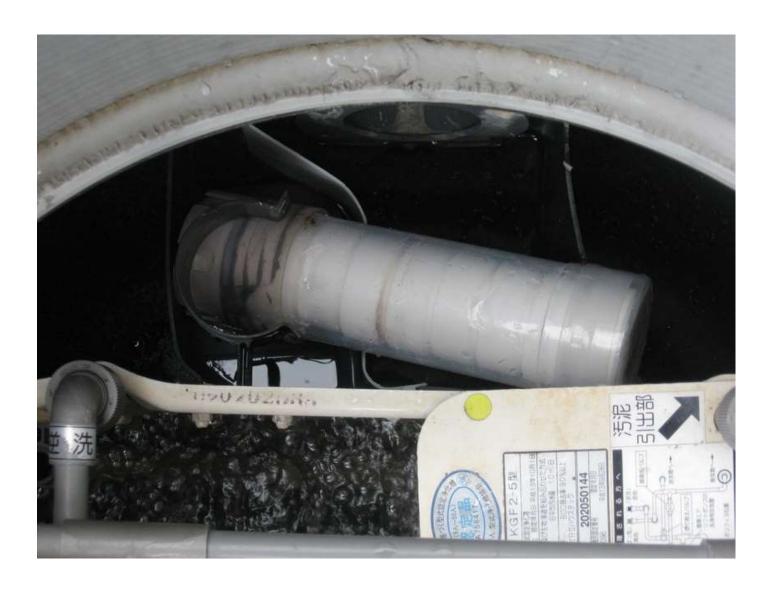
Inflow of rubble by adverse water current

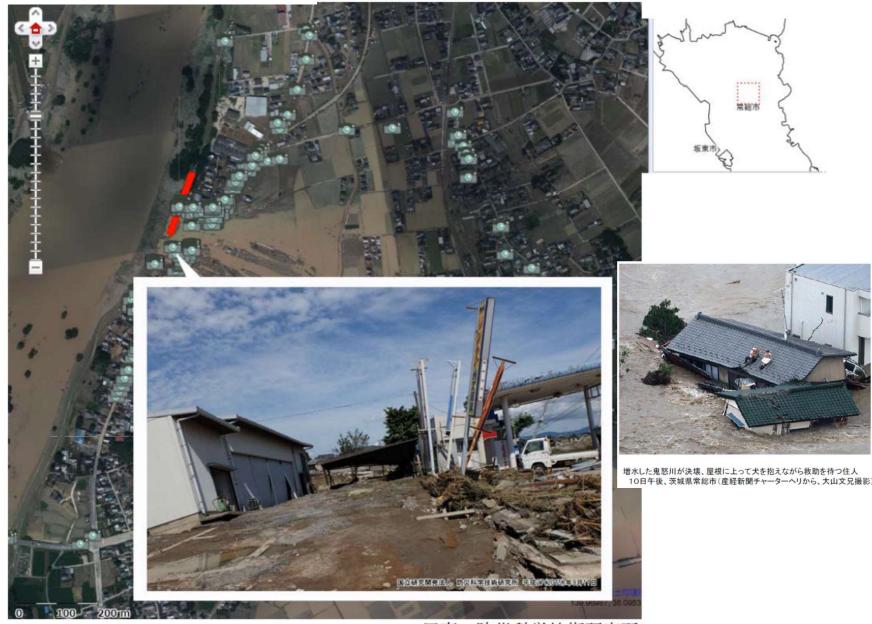
Severe damage often occurred near washout point of river

Very close to the levee breach site

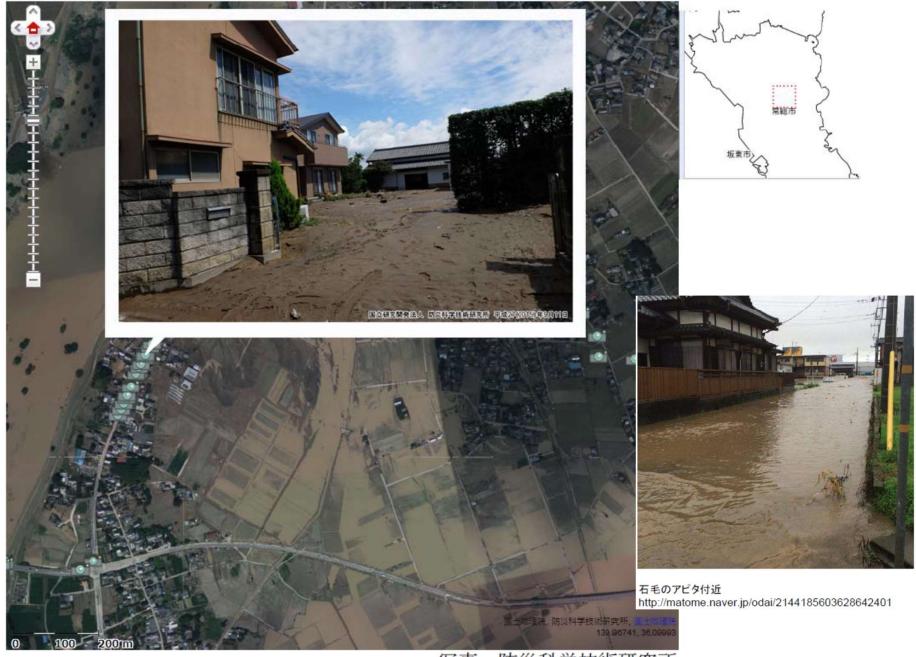
Downstream area of the levee breach site

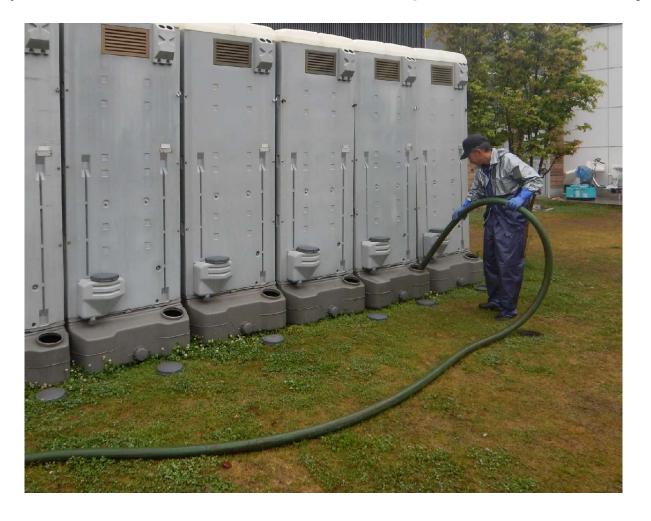
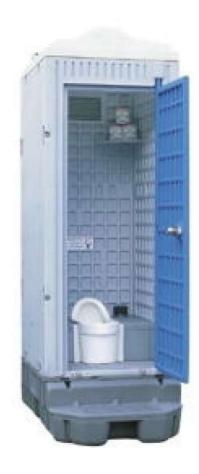
Temporary toilet at evacuation shelter

(Case of maintenance of simple vault toilet by desludging vendor)
