# Situation of wastewater management under disasters

Kikuya Shibata

Secretary General of Miyagi Prefectural Authority for Living Environment

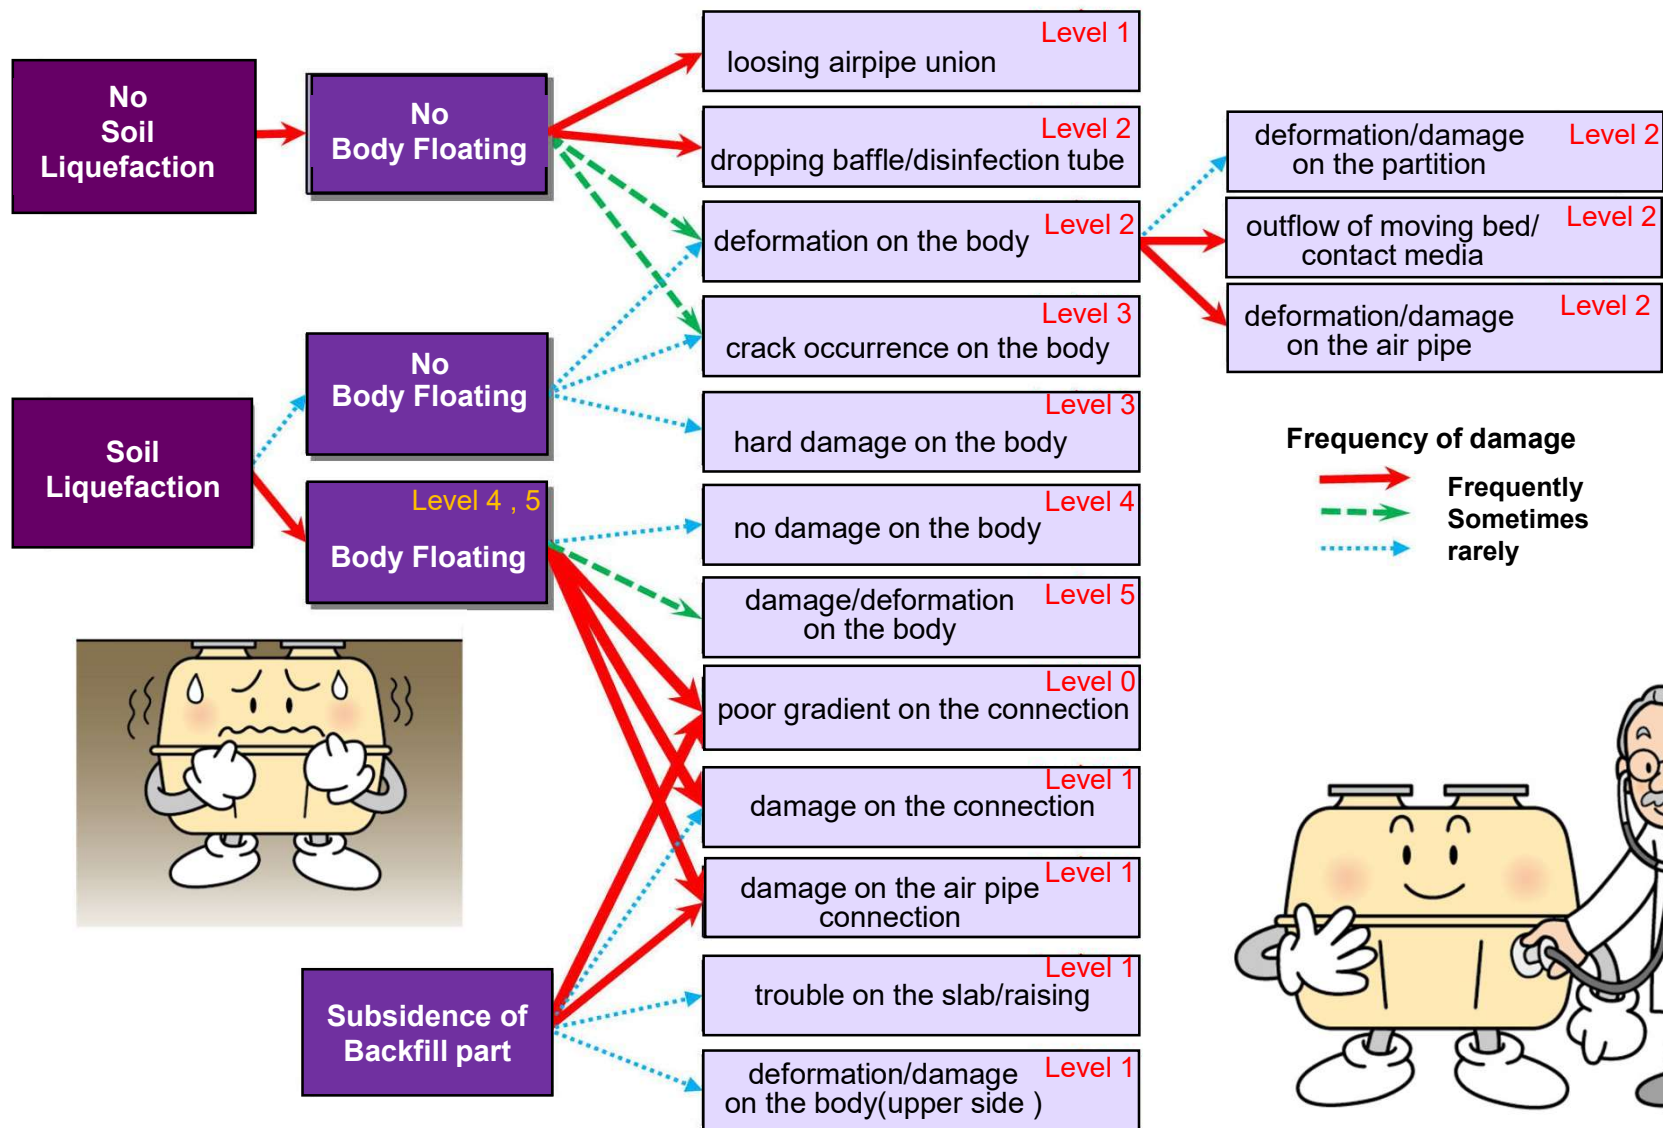
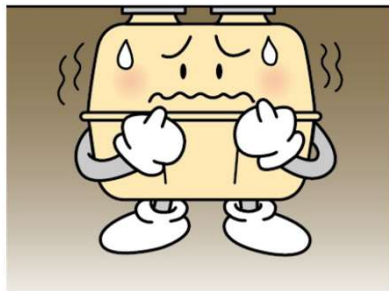
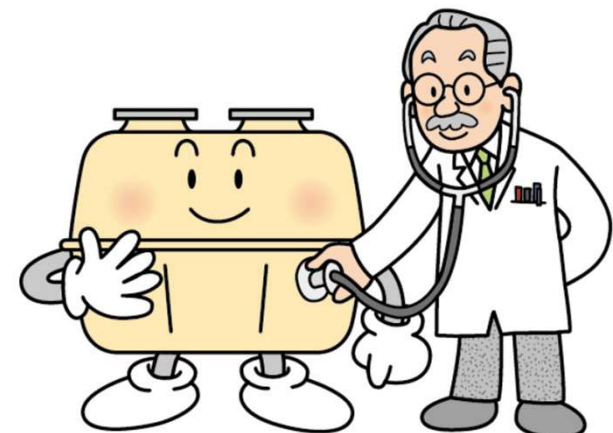
# 4.2 Classification of damage for Johkasou caused by an earthquake (Classified by the presence or absence of liquefaction)

The three points of Johkasou damage that can be seen from the case of the Great East Japan Earthquake

- ① The Johkasou with support post, there is almost no surfacing due to liquefaction.
- ② Most of the surfacing of the body is due to the liquefaction of the backfilled part.
- ③ Floating prevention metal fittings are intended for static groundwater and are not supposed soil liquefaction around the Johkasou.

Preventing soil liquefaction of backfill part is the "basic concept of an earthquake-resistant Johkasou."

Eliminate one of the following three factors which lead soil liquefaction.

- ① The ground water level in the backfill area is high.
- ② The grain size distribution of soil used for backfill area is easily liquefied.
- ③ Low degree of sand compaction of backfill area.
