Earth Creative

2. Wastewater treatment System in Indonesia

2. Wastewater treatment system in Indonesia

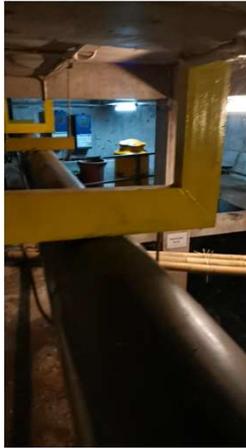
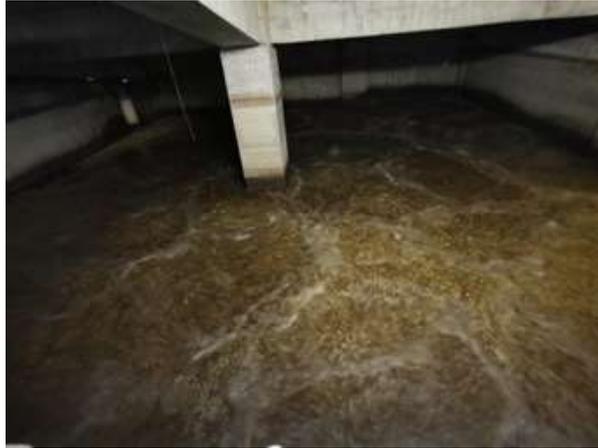
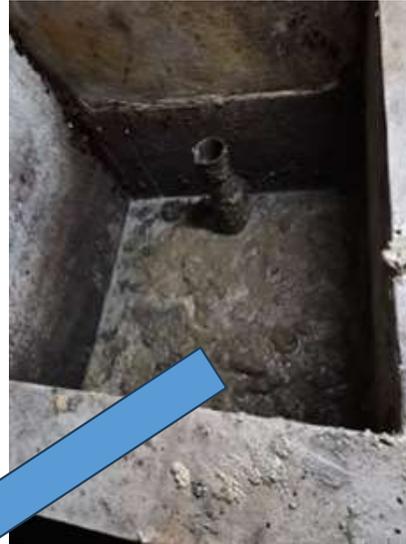
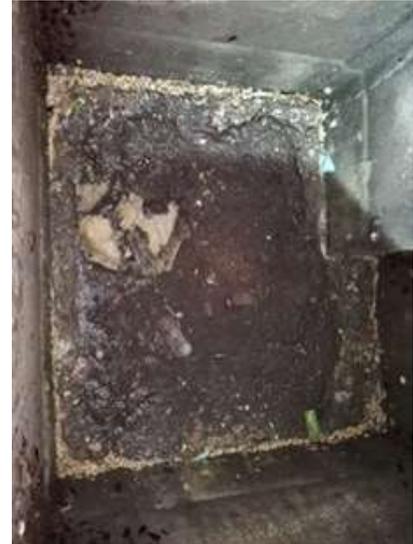
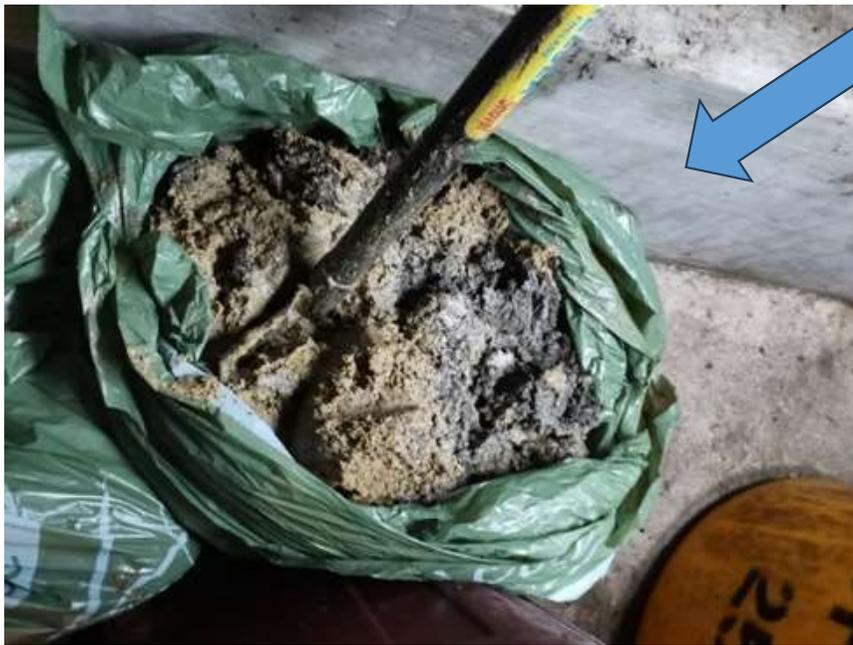
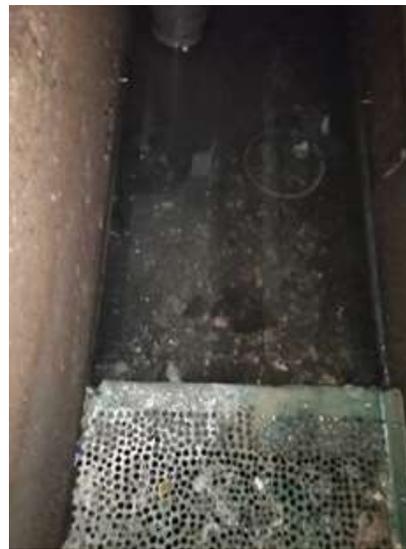
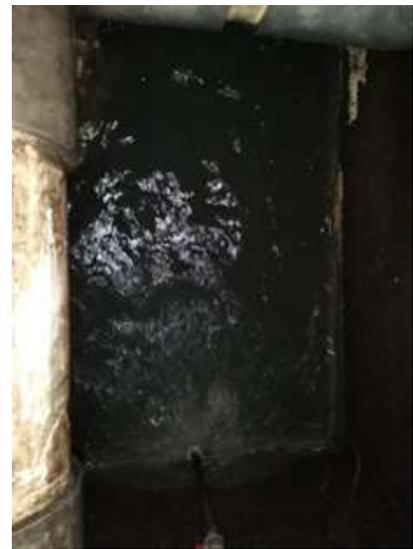
Case 1 : Hotel

浄化槽内清掃

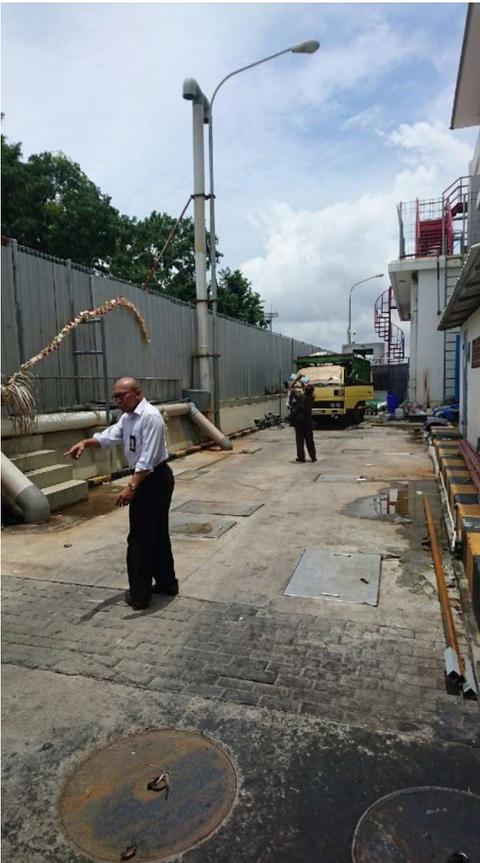
2016

Case 7 Food Processing Factory
